# Red Gym Building Analysis

(2024)

Danny Her & Robert Corbett

Madison College

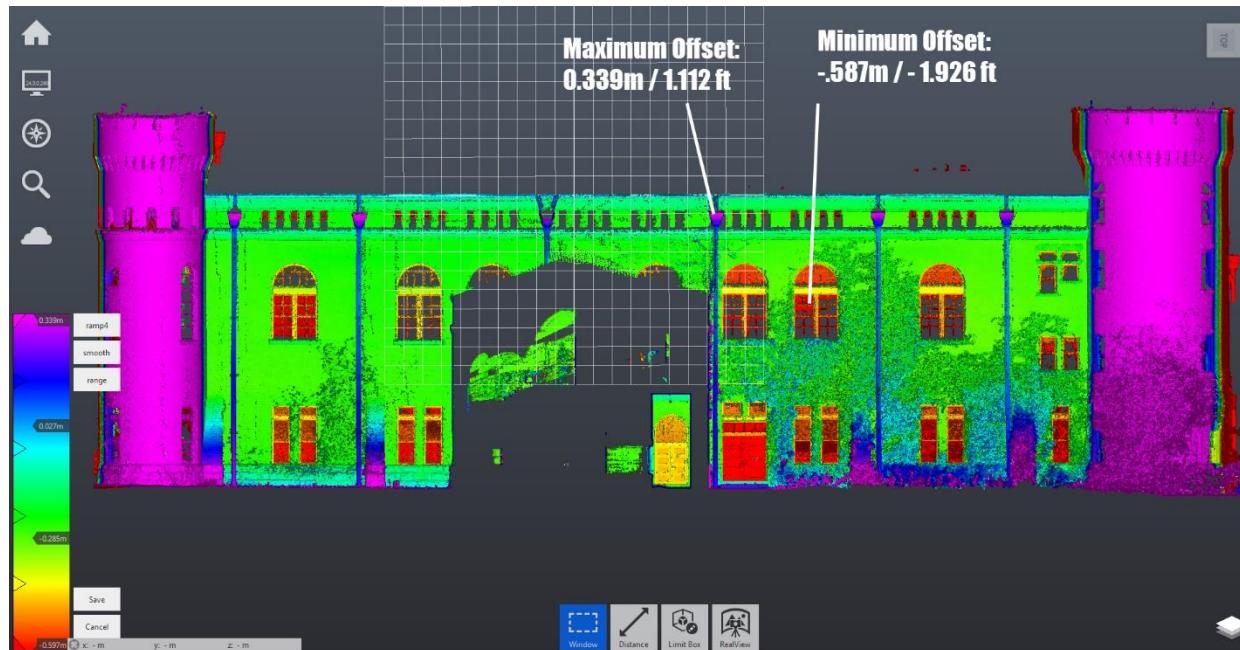
in Recap to detect any wall deformities. There does not seem to be a large variation of wall deformation using Autodesk Recap for the west wall.

(Autodesk ReCap) Reoriented west wall using elevation points.

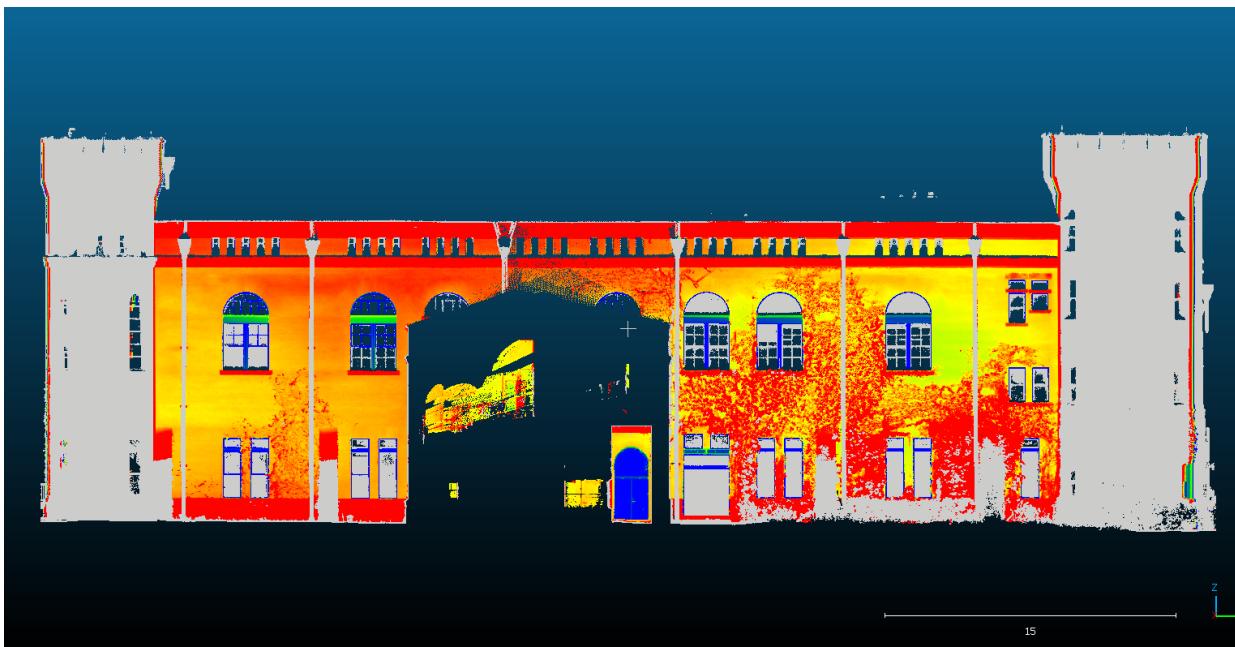
Using scalar fields in Cloud Compare to assess west wall deformation.

The west wall can be observed to have a slight bulge in the upper portion of the wall. In the north wall, the second floor of the building is receding back into the building.

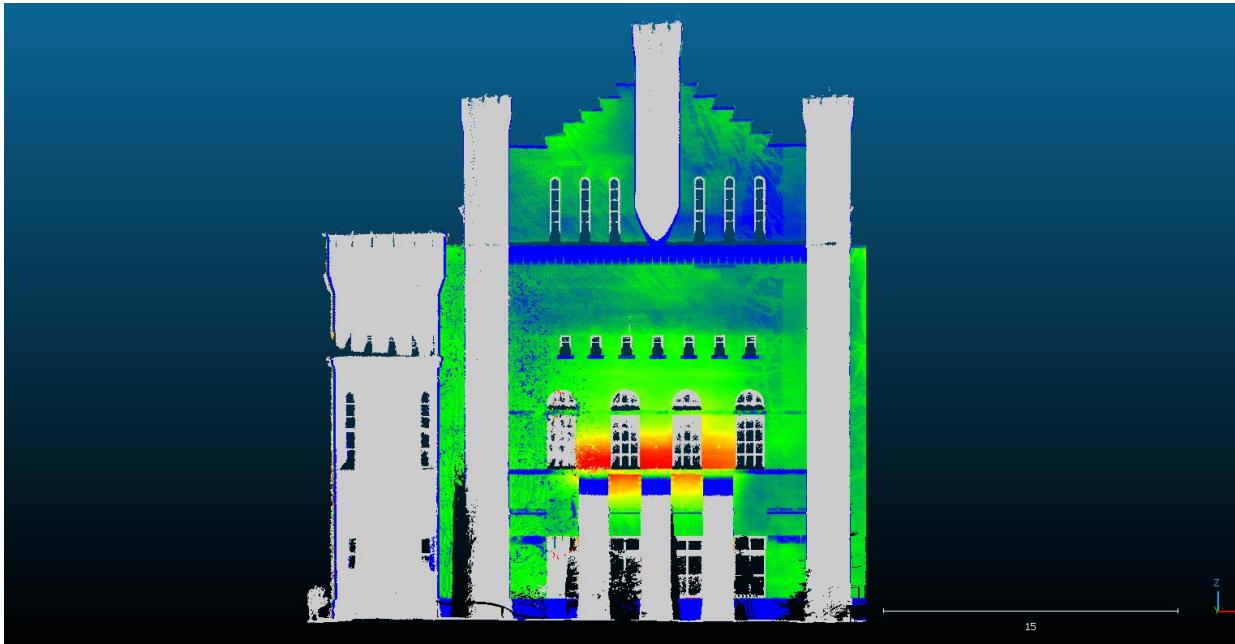
Using scalar fields in Cloud Compare to assess north wall deformation.

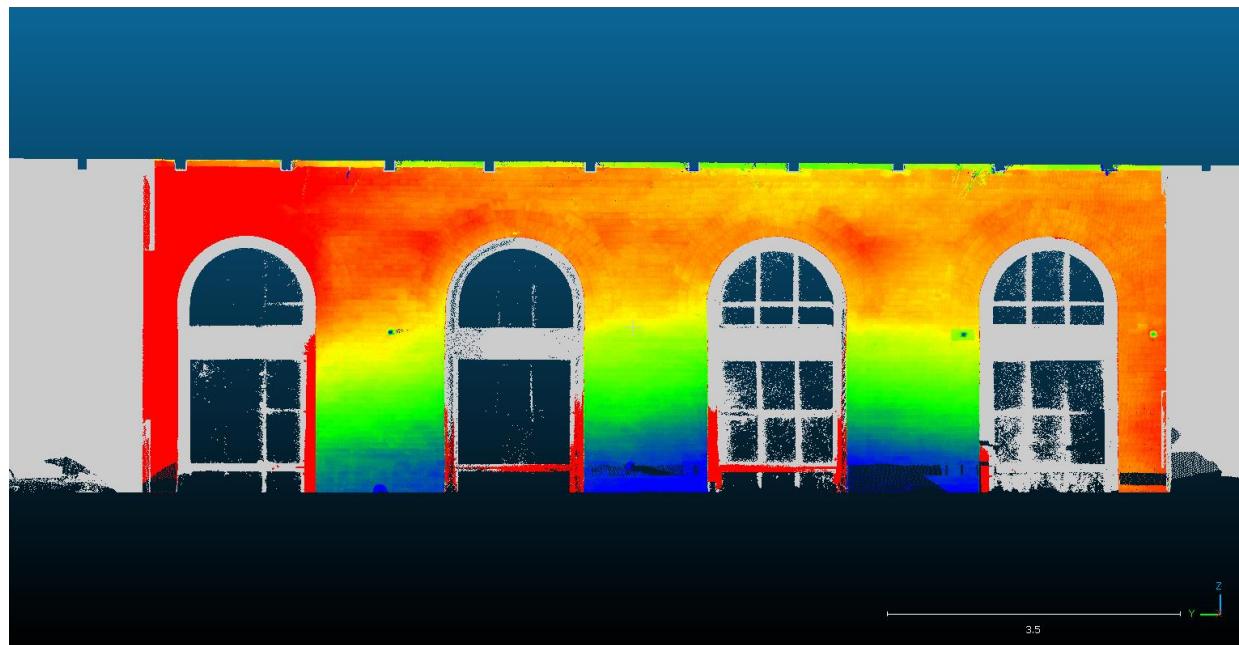
Interesting differences can be observed by using scalar fields. The interior of the 2<sup>nd</sup> wall seems to have a noticeable wall deformation. The bottom half of the wall is protruding forward. The interior of the north wall on the 3<sup>rd</sup> floor is observed to have variations in deformation. On the bottom half the wall is protruding. On the upper portions of the windows, there are deformations that seem to align with stress cracks.

Interior of the 2<sup>nd</sup> floor north wall.

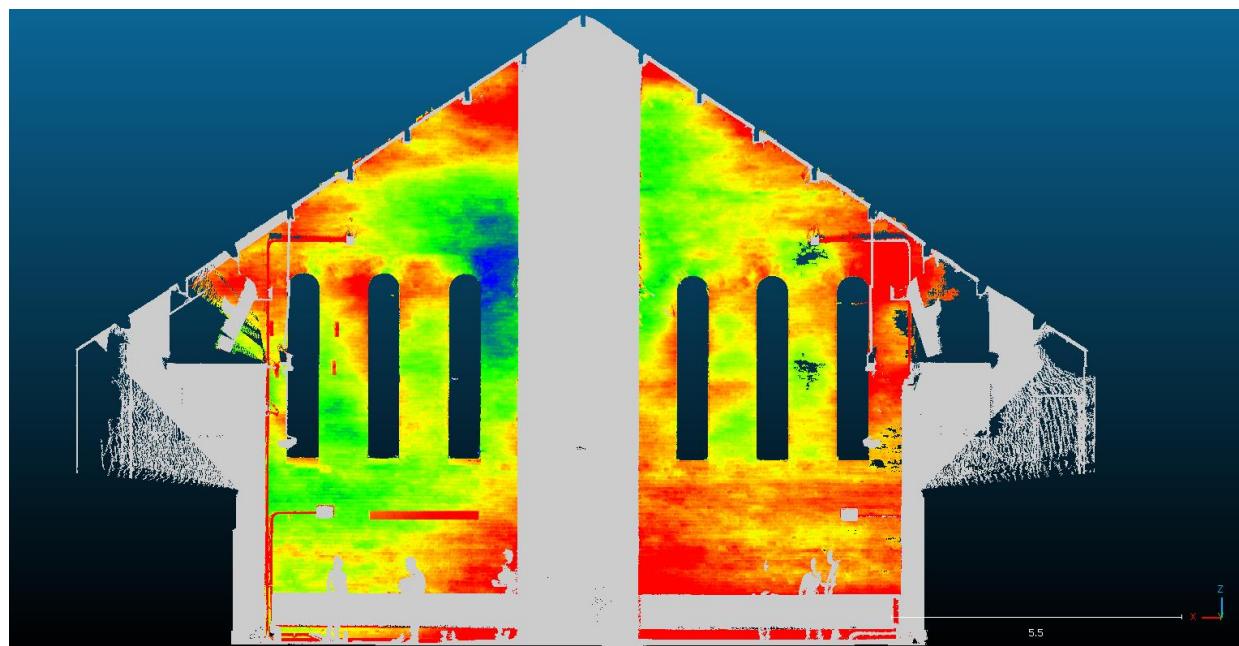
Interior of the 3<sup>rd</sup> floor north wall.

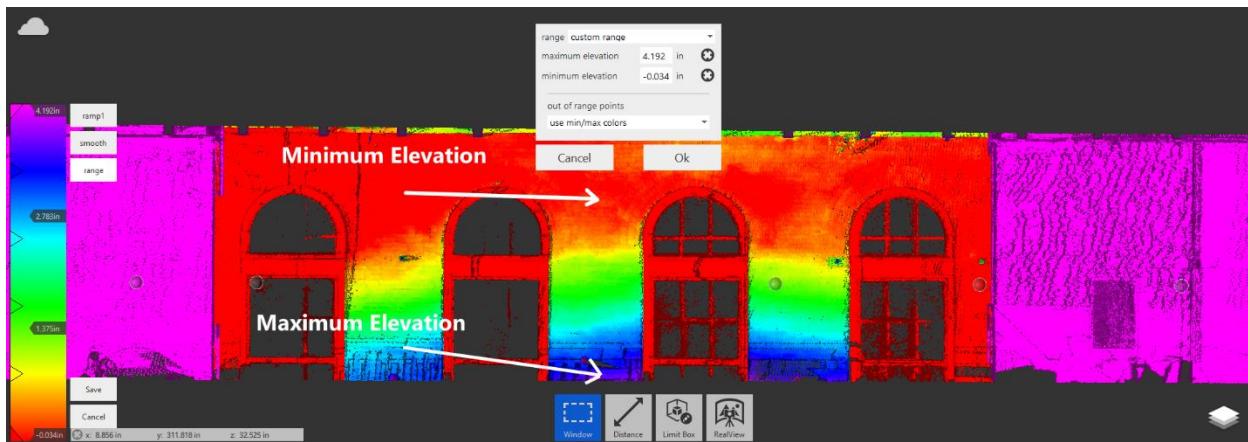
Using the Autodesk Recap elevation tools, it can be observed that there is an approximate 4-inch deformation in the north wall on the second floor. The deformation originates between the windows and the top of the brick supports on the exterior.

Red Gym Interior North Wall Second Floor (Recap)

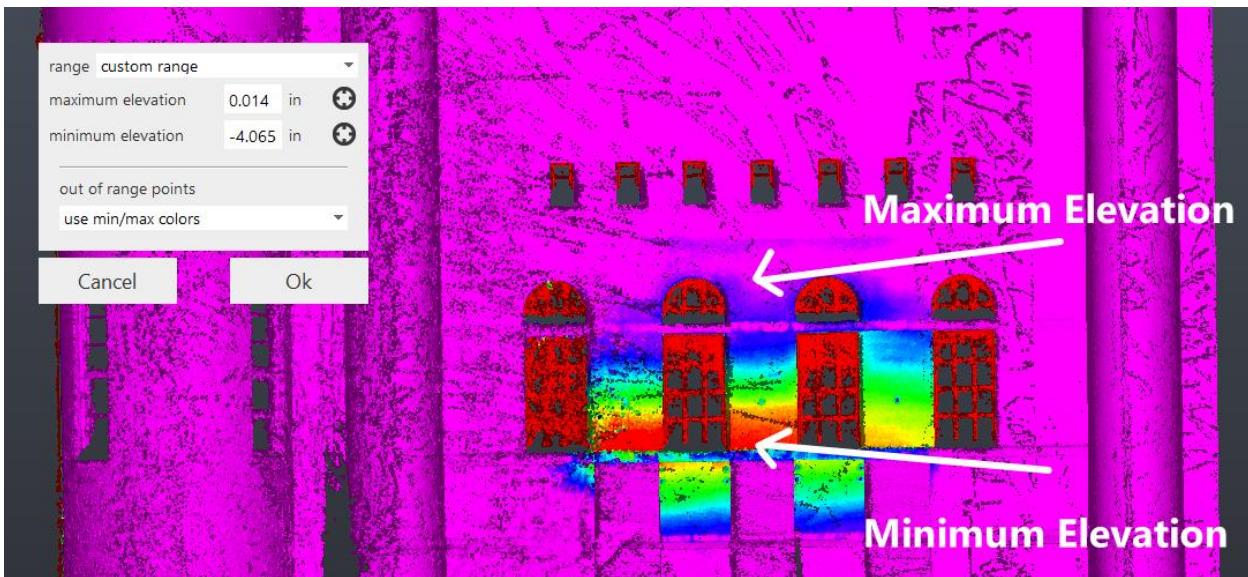
Red Gym Exterior North Wall Second Floor (Recap)

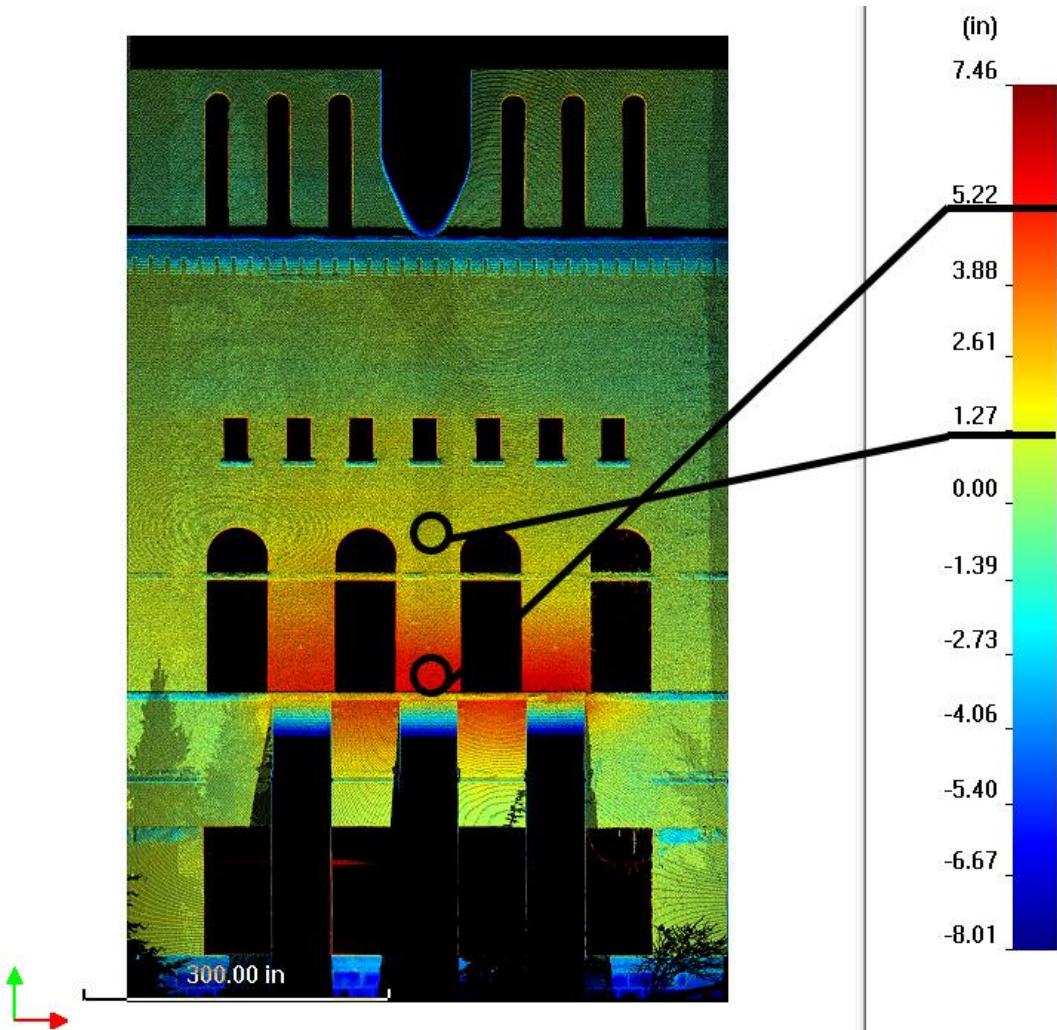
Exterior inspection map of the Red Gym's north wall.

After applying various methods to inspect the west and north walls of the Red Gym, it can be determined that there are a few areas of the walls that have wall deformations. The biggest deformations can be detected on the exterior of the north wall, and the interior of the 2<sup>nd</sup> floor on the north wall. Minor wall deformations of approximately 1 inch can be detected on the interior of the third floor. There is also an inch deviation that can be detected from the two sides of the west side wall.

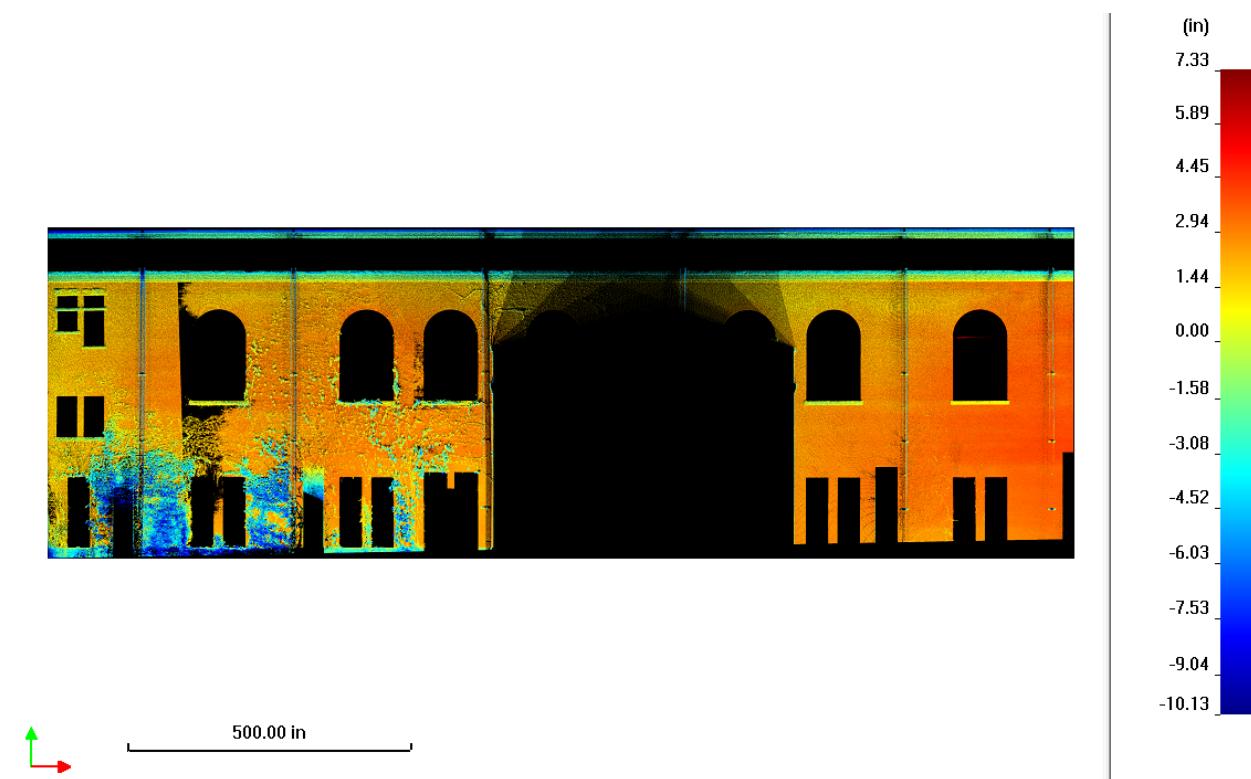
Exterior inspection map of the Red Gym's west wall.

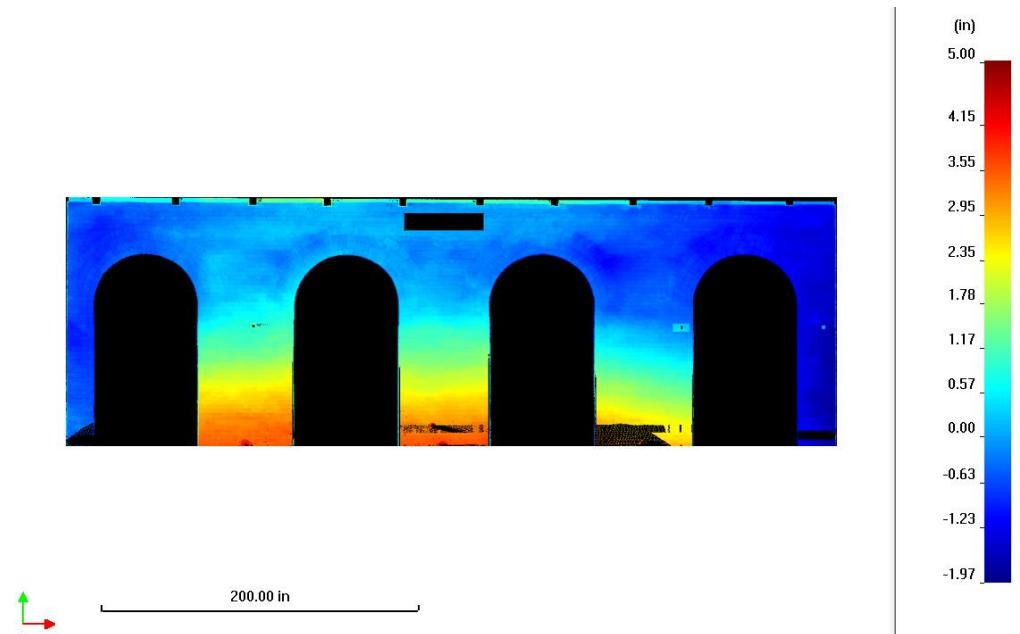
Interior inspection map of the Red Gym's north wall 2<sup>nd</sup> floor.

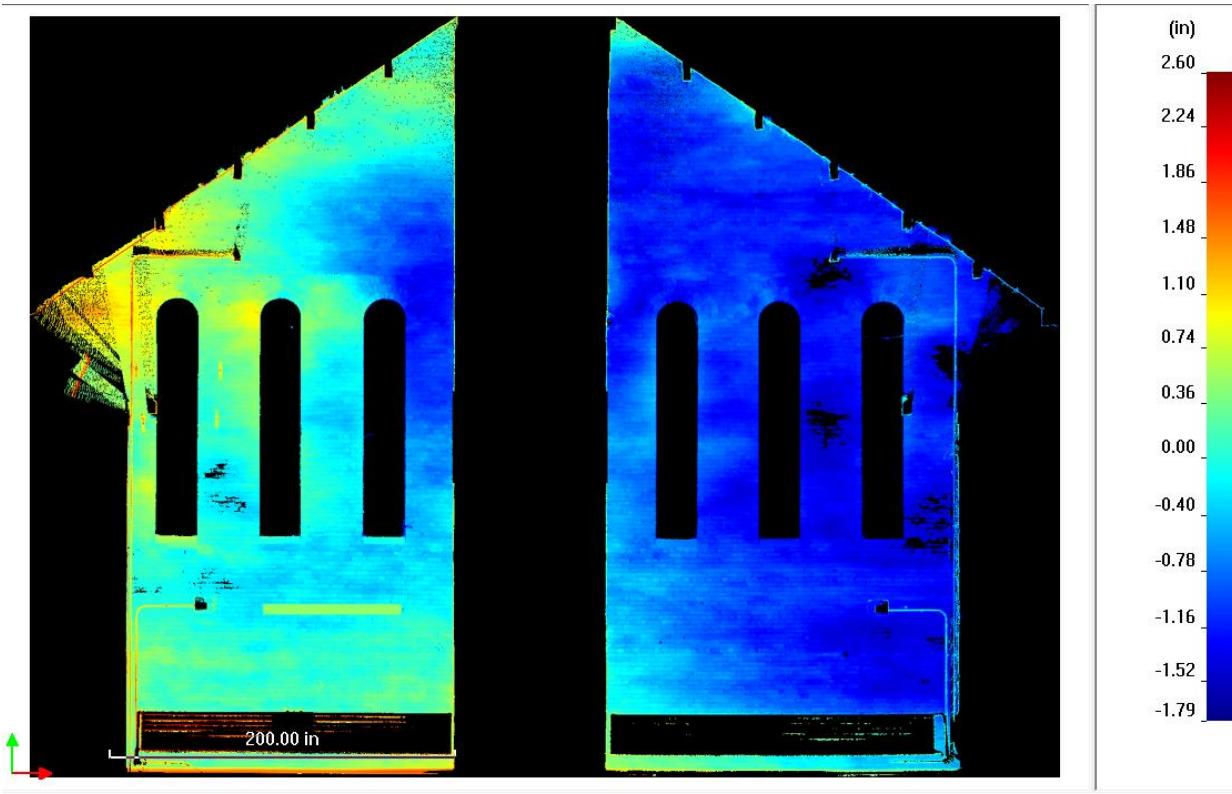
Interior inspection map of the Red Gym's north wall 3<sup>rd</sup> floor.

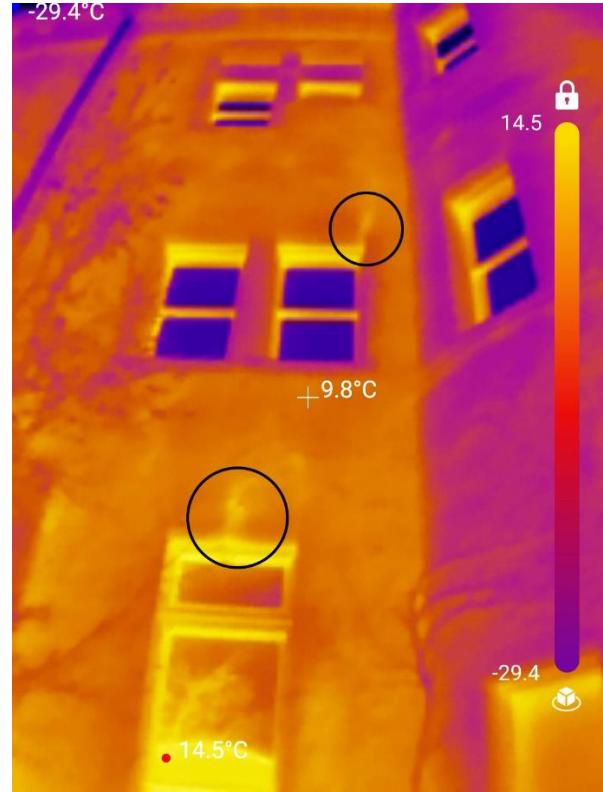
Observed deformation on the exterior and interior of the north wall. Infrared thermal images display stress cracks and heat loss.

Thermographic images with hidden cracks.
