# Red Gym Building Analysis

(2024)

Danny Her & Robert Corbett

Madison College

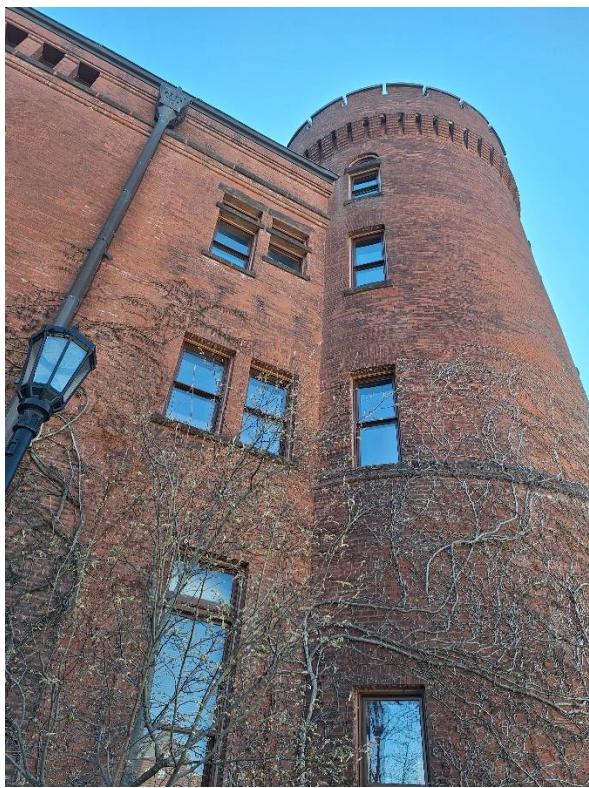
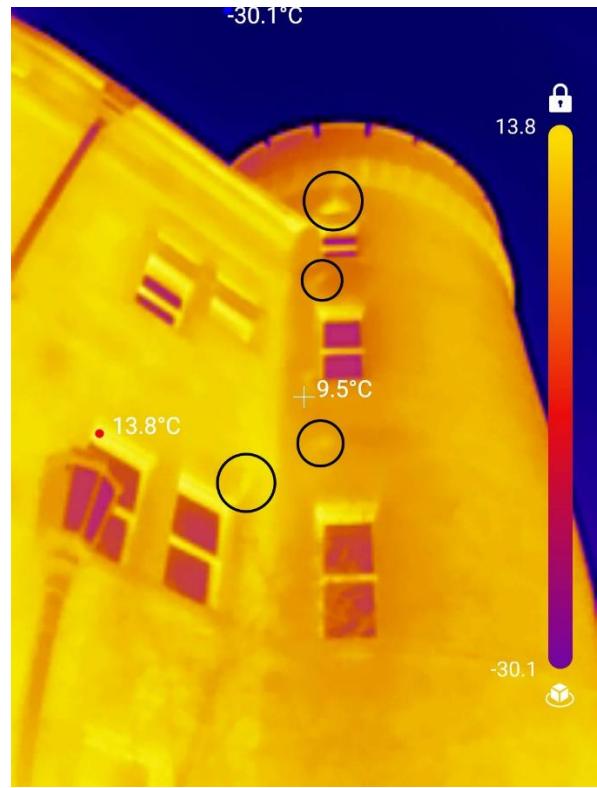
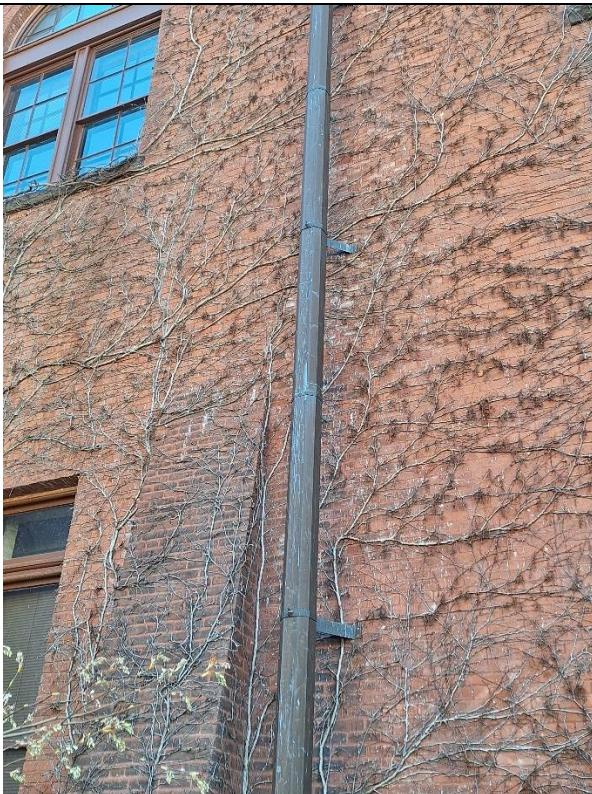
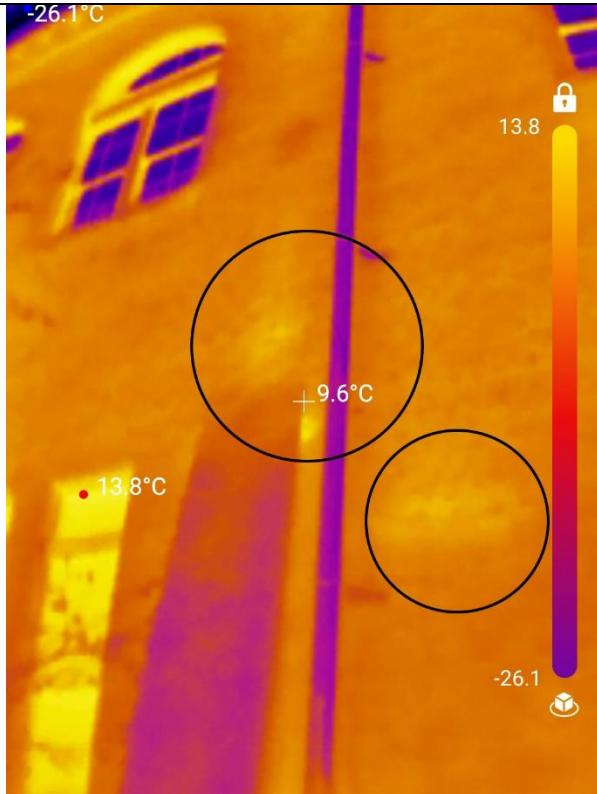
Observed deformation on the exterior and interior of the north wall. Infrared thermal images display stress cracks and heat loss.
